FURNEAUX CREEK 5 CHANNEL AND TRAIL IMPROVEMENTS

TEXAS CHAPTER AMERICAN PUBLIC WORKS ASSOCIATION

PROJECT OF THE YEAR

**CATEGORY: ENVIRONMENT PROJECT OF \$2 MILLION BUT LESS THAN \$5 MILLION
ENGINEERING DEPARTMENT, CARROLLTON TEXAS**

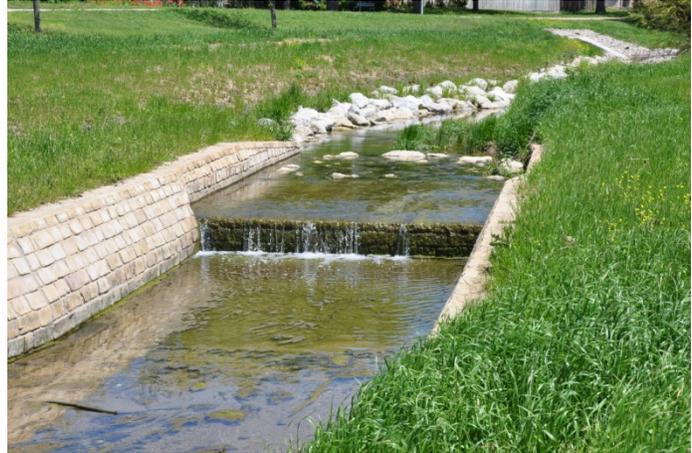
The channel consists of a trapezoidal section. Most of the channel has a bare earth bottom with large rock rip rap on the lower section of the channel slope. The large rip rap (36-inch) provides toe protection for the bottom of the slope. It extends about 3 feet

below the flowline of the channel. The bottom of the channel is typically about 10 to 15 feet wide and the depth varies from about 2 feet to over 7 feet. The channel includes six drop structures, each with a drop height of about 2 to 3 feet. These drop structures include vertical walls with milsap façade and gabions to protect the areas behind the walls. These drop structures reduce the channel grade which, in turn, reduces channel velocities to 6 feet per second or less.

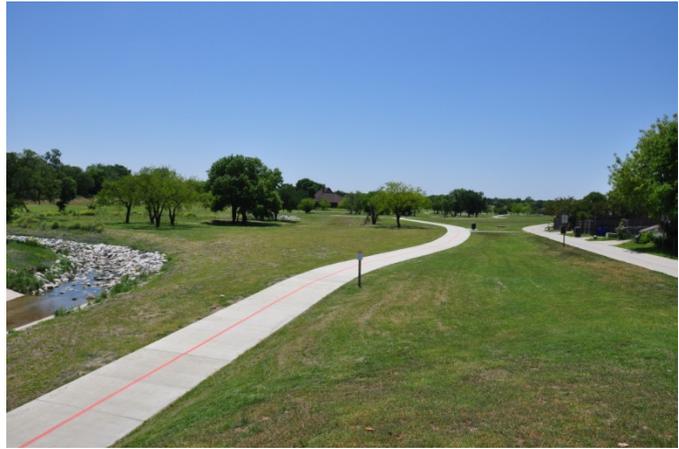
The trail winds through the greenbelt, paralleling the trail in many areas, then loops on the upstream side of the site. The trail is designed as both a walking/jogging trail and a bicycle path. The 10-foot wide trail consists of a 6-inch thick fiber reinforced concrete

section on a compacted subgrade. We have found that the fiber reinforcement holds up well for this application and is cheaper and faster than traditional reinforcing steel.

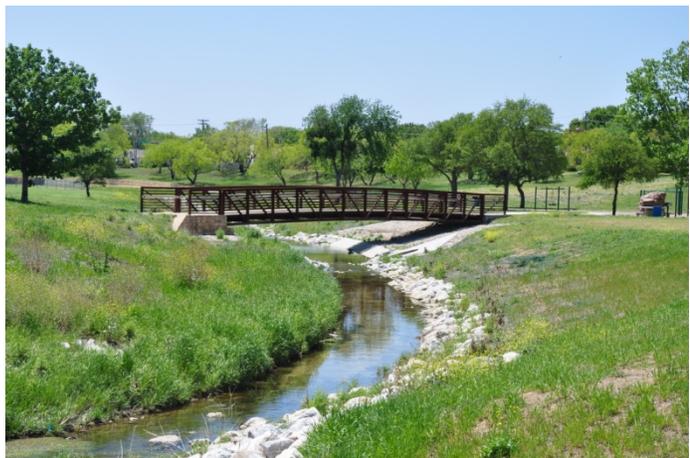
The trail includes multiple crossings. Two are low water crossings, with small rectangular openings that provide for low flows to pass underneath and larger flows to overtop. One of the crossings is a steel and concrete pedestrian bridge which spans the entire channel. There is also a 'mid level' crossing that will be overtopped during severe events, but more frequently than the steel bridge (approximately 2% design storm).

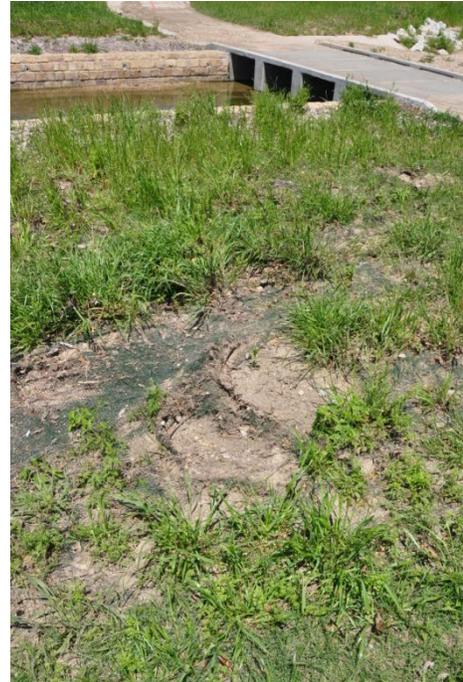
For this project, the amount of geotextile fabric required hindered grass establishment as well as high velocities on the overbanks. As the photos shows, even anchored geotextiles were damaged due to high flow conditions.

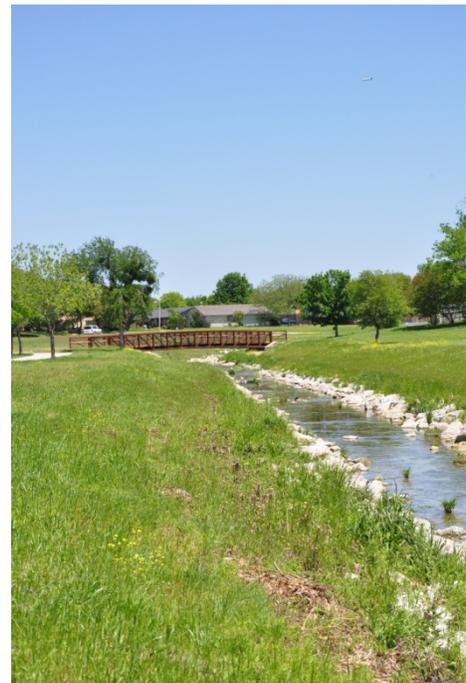
We have had a few rainfall events since completion of the project. We have had to add additional geotextile fabrics in areas subject to erosion. Currently the vegetation is nearing enough coverage and maturity to withstand mild rainfall events. This spring will likely put it to the test.
